TECHNICAL FIELD VISIT

DATE: January 28, 2000**DOGM STAFF:** Robert Davidson**ATTENDANTS:** Chris Hansen and Quay Meacham, Canyon Fuel Company, LLC
Jim Shade, private welding contractor**RE:** Link Canyon Substation Pad #2, Canyon Fuel Company, LLC, SUFCO Mine,
ACT/041/002, Sevier County, Utah**Purpose:**Compliance

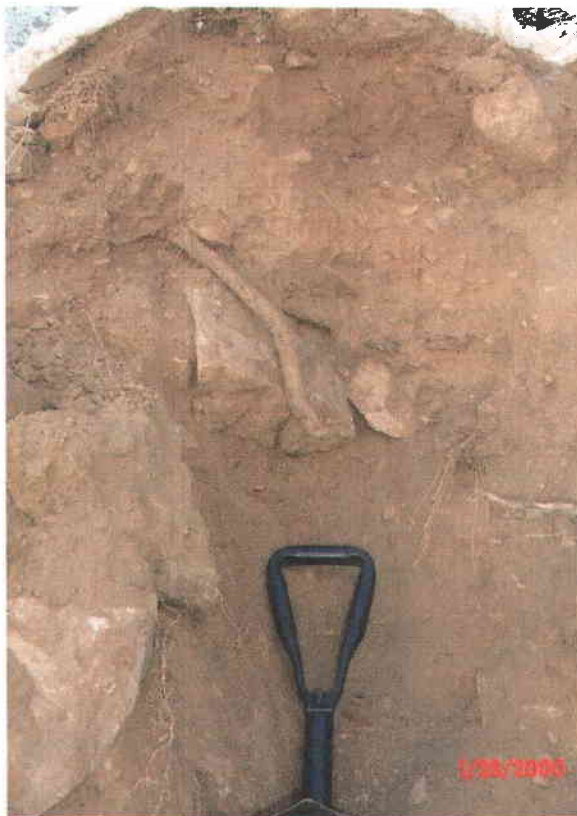
- Field characterizations were made as follows:
 - 0 to 1 feet Silty sandy loam, damp, loose with no structure. 10% gravels. 1% fine coal. The soil was mixed containing plant litter and fine roots. Moderate to strong reaction using 10% hydrochloric acid.

Figure 1. Soil pit, side wall.

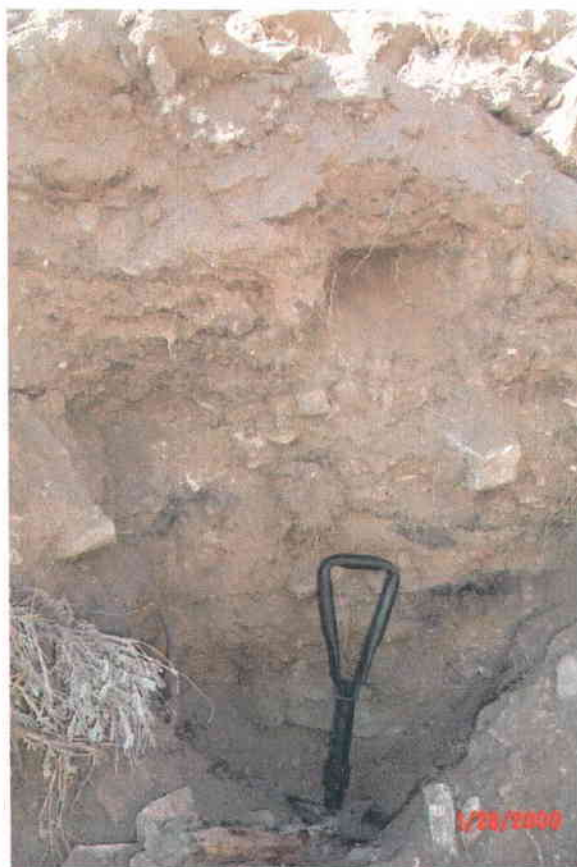
- 1 to 4 feet Damp and loose with no soil structure. 15 to 20 % fine to coarse angular gravels evenly dispersed; 5% fine to coarse angular cobbles. 1% coal. Abundant fine roots throughout profile. Strong reaction using 10% hydrochloric acid.

Figure 2. Soil pit, back wall.

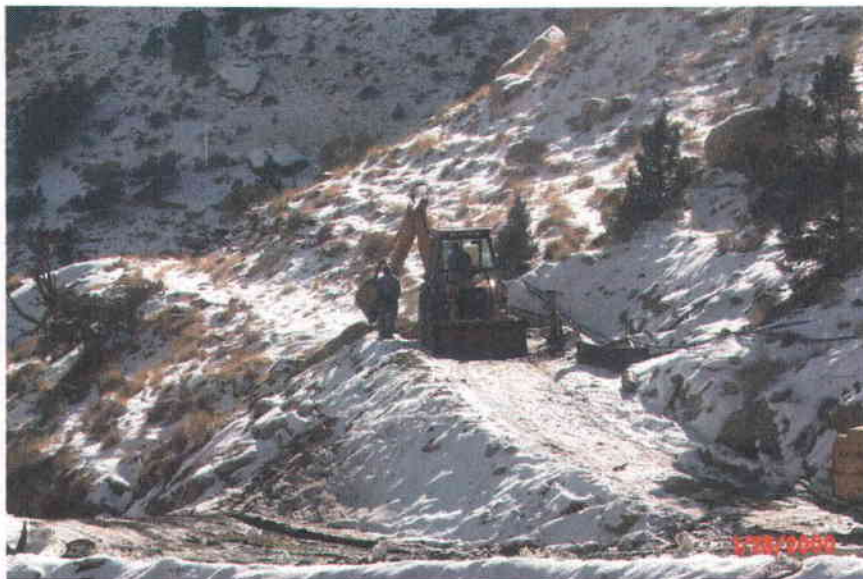
- Using a backhoe, dug one soil pit on the outslope of the old tramway road. This area has recently been disturbed for accessing cables and communication lines from inside the mine. The outslope has received additional soils from this disturbance. The outslope was estimated to be 45 degrees. The pit was dug to a depth of four feet before encountering shale material. The perpendicular depth measured four feet.

Figure 3. Link Canyon Substation Pad #2 soil pit location - old tramway road outslope.

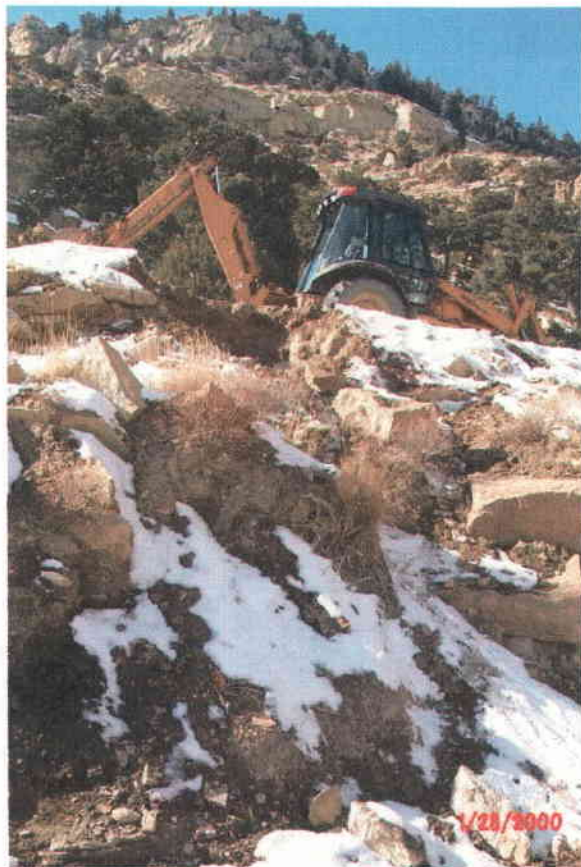
Figure 4. Soil pit location as viewed below the tramway road outslope.
